## Critical design, testing and manufacturing features for the selection of high quality composite insulators for transmission overhead lines

Jean-Marie George  
Scientific Director  
SEDIVER  
Email: [jmgeorge@sediver.fr](mailto:jmgeorge@sediver.fr)

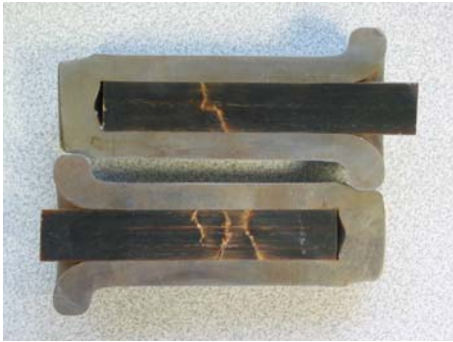
**Figure 4** : crack in the rod after excessive or uneven crimping operation. The crack is far enough inside the end fitting to go through the mechanical routine test without being detected.

This process, based on friction, will transfer to the rod the pressure resulting from the applied force with quite substantial differences from one blade to the other. Furthermore, this type of equipment will suffer of mechanical ageing typical of a friction process. To cope with such fluctuations and inherent lack of consistency, some manufacturers will use a rod of a larger diameter than what is required from pure mechanical strength considerations. The risk of damage to the rod remains however high, and small cracks might exist which are not necessarily critical enough at this stage to be caught in mechanical routine tests. Additionally, more important cracks (figure 4) might exist in the rod length inside the fitting leaving a crimped surface with sufficient strength for a routine test. Dynamic loads or thermal cycles over the course of time might make this a critical issue in the long run.

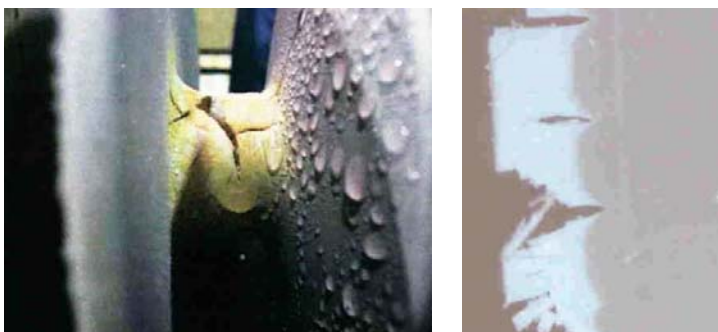
**Figure 6** : silicone rubber degradation related to acid and detailed cross section.

- b) Recent work has shown the influence of acids on silicone housing. Under corona activity, with the generation of ozone, nitric acid will be present on the surface of the housing. Also, some reports of acid related degradation in specific chemical industrialized area (sulphuric acids...) are showing that silicone rubber can be degraded under such environments (figure 6), unlike EPDM. Acid tests are not yet described by standards, and while work is still needed, there is a clear indication that this represents a major threat for composite insulators. Figure 7 gives a comparison between two silicone rubber formulations slightly different in the selection of fillers tested in the laboratory in an acidic environment. It seems obvious that specifying optimum silicone rubbers requires far more detailed description than a generic wording.

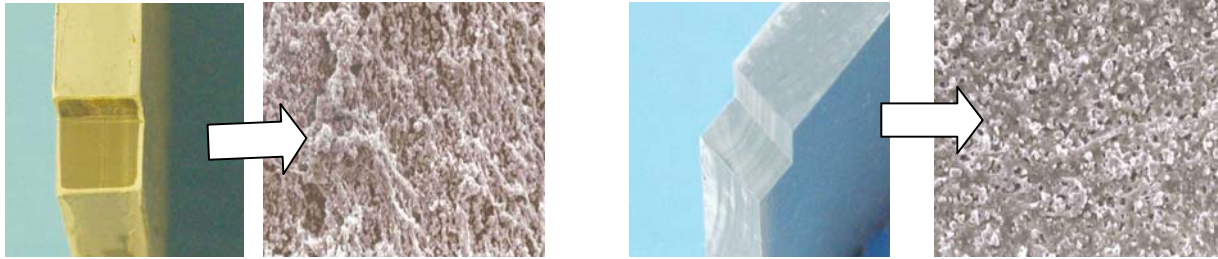
a) silicone degraded by acid test

b) silicone with optimum protection against acids

**Figure 7:** Test samples of two different silicone rubbers and electronic microscopic detail of silicone compound structure after acid related degradation. (laboratory test)

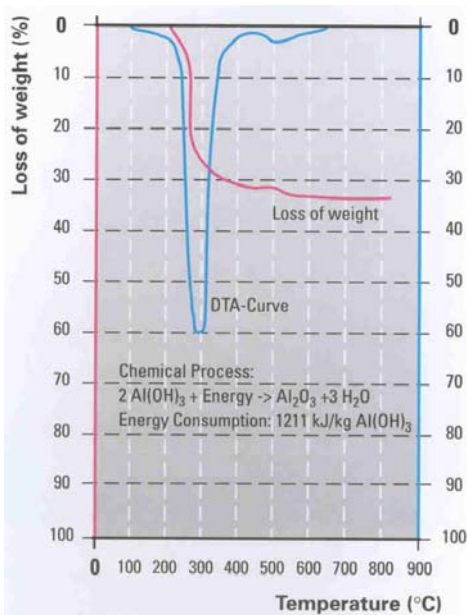
**Figure 9:** Typical thermo gravimetric curve

In order to be capable to sort out between a large spectrum of silicone rubbers, one might consider the level of ATH filler as a preliminary condition. ATH levels can be estimated by thermo gravimetric analyzes (figure 9). Under such requirements, silicone rubber should be capable to comply with very stringent acceptance criteria based on inclined plan (1A4.5) test results, tracking wheel test, and combined clean and/or salt fog tests. Such curves can be required on the bases of comparing material used during qualification and sample testing.

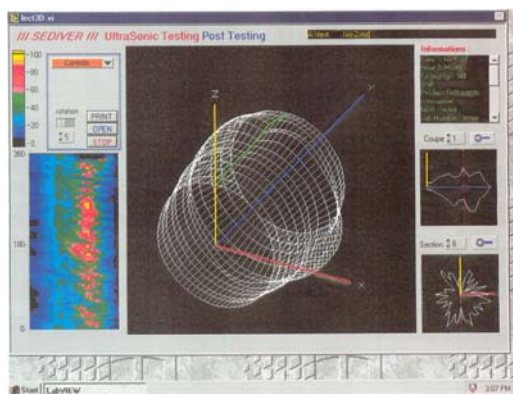
Besides the end fitting seal, there is a critical need to ensure the good adherence between rod and rubber, along the longitudinal line separating the end fittings. Advanced technology for non destructive controls (7) is possible thanks to ultrasounds which will assist the control of the molding or any rod covering process. (figure10)

**Figure 10:** Ultrasound control of the longitudinal interface
